Transport
Canada

TP 6980E

Issue 2/2004

Canadian Aviation Service Difficulty Reports

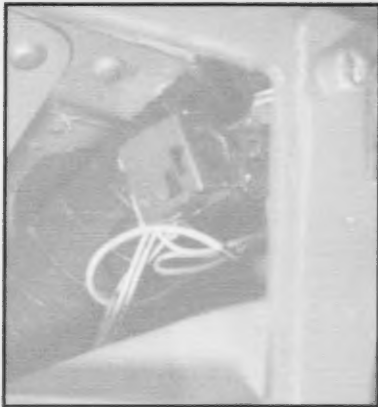
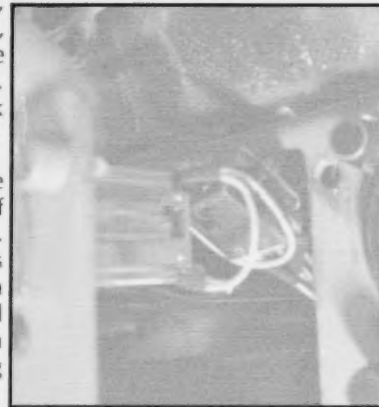
SDR # 20031008001

Firex Testing Failure

Upon completion of a Phase 2 inspection, the submitter discovered that the left, P/N 11991, and the right, P/N 11992, fire extinguisher activation failed to test. Further investigation revealed the back part of the switches had fallen off.

When pushed, the indicating part of the switch contacts the activation portion of the switch that normally fires the squib. The activation part of the switch is attached to the back of the indication portion with clasps. The clasps had failed allowing the activation part of the switch to fall off of the indication portion leaving the system fully disabled.

Time Since New (TSN): 16,822 hours

The submitter added that Raytheon recently added the fire extinguisher activation check to the Phase 2 inspection.

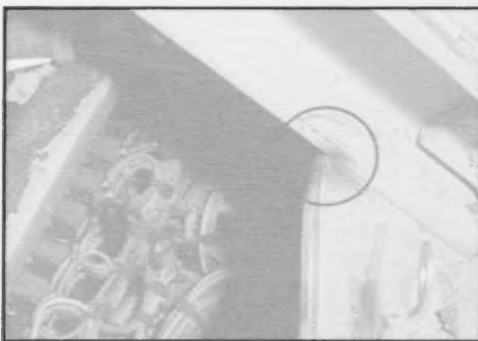
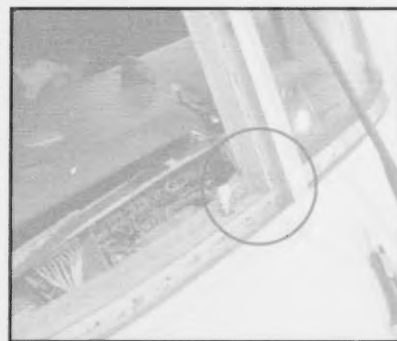
SDR # 20040303004

Windshield Pillar Gusset Chafed

While removing a broken co-pilot windshield, chafing was discovered on the windshield frame. The interior trim that is attached to the center pillar had become unattached and had fallen down and contacted the windshield pillar gusset.

Raytheon was contacted and a repair scheme was forwarded to the submitter, allowing the aircraft to return to service.

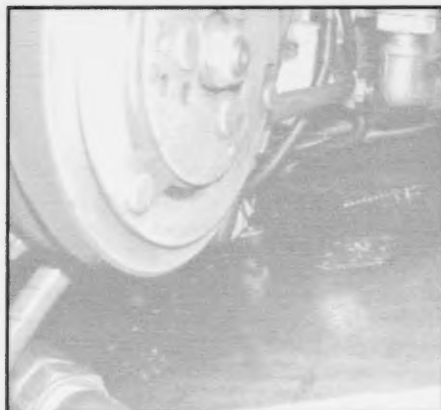
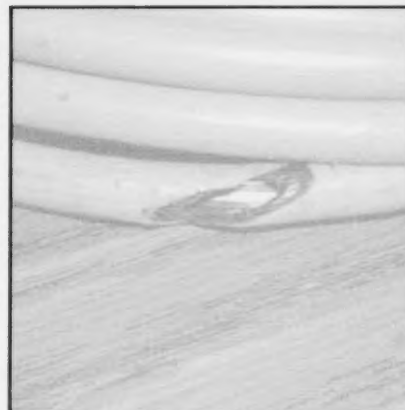
SDR # 20040309001

Power Level Cable Severed

After landing and subsequent taxi, the right engine spooled up and did not respond to power lever movement. The engine was shut down and the aircraft completed taxi to the terminal on the left engine.

Maintenance investigated and discovered that the pulley of the vapor cycle air conditioning system had severed the power lever cable, P/N 1143890503. The cable had been routed too close to the pulley during an engine removal and reinstallation 64 hours prior to the incident.

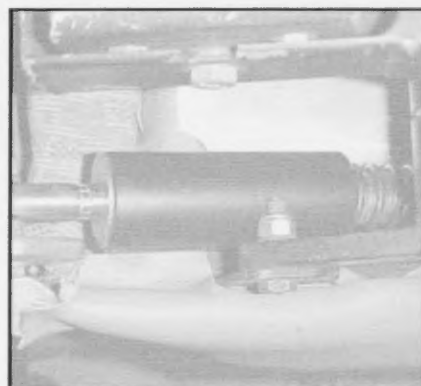
SDR # 20040216006

During the pre-flight phase, the pilot attempted to adjust the L/H seat when the seat back dropped back well beyond its normal range of adjustment. It was determined then that the seat was not in a safe condition to use and the crew made an entry in the logbook thus grounding the aircraft.

Closer examination of the seat adjusting mechanism by the maintenance personnel revealed that the aft rod attachment for the lock cylinder had sheared where the rod is secured into the end cap. The crimp remained intact whereas the shear occurred just forward of the crimp directly causing the seat adjustment mechanism to fail. A new replacement part was ordered from the manufacturer.

Research of the SDR database has found one other record with this part number. AME's are reminded to check this particular area when performing a seat inspection.

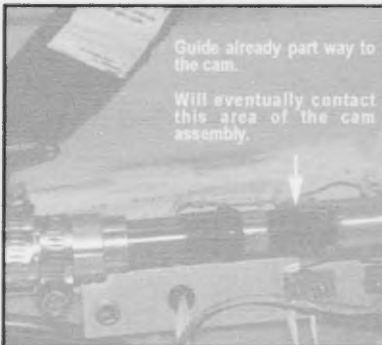
It was discovered that the splined rubber seal pushed out of position on flap actuator rod assembly, P/N 222750010. On this particular aircraft, it did not make contact with the flap position switches. The complete assembly was removed and sent to Diamond for inspection. A new assembly was installed.

Actuator in the take-off position

This was the fourth occurrence of this nature for this operator. The submitter added that the manufacturer suggested cleaning the area with alcohol and to re-glue the seal using Loctite 409 adhesive.

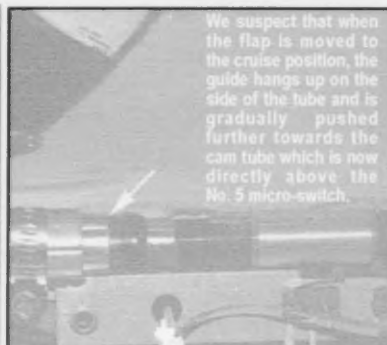
Actuator in the cruise position

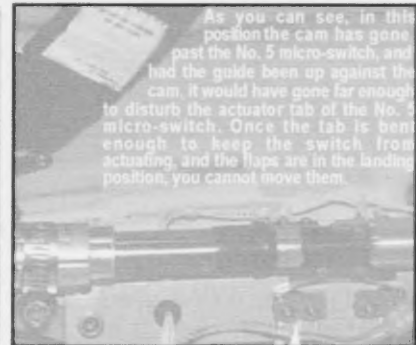
Actuator in the landing position

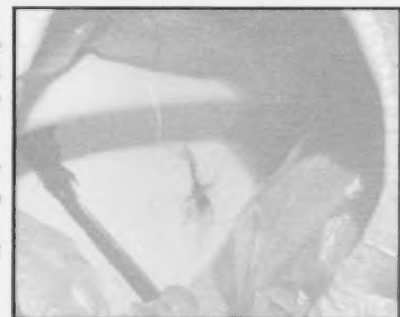
During cruise, a cockpit ceiling-mounted map light failed and the applicable circuit breaker tripped. In subsequent troubleshooting, the roof panel was removed with discovery of the lamp terminal, P/N 2527, in contact with the airframe structure.

This anomaly caused the rubber protective boot on the terminals to wear through and ground out the electrical supply. A spacer ring under the lamp collar was installed and sufficient clearance from the fuselage was obtained. The submitter carried out a fleet inspection and discovered one other aircraft with a similar discrepancy.

The P180 Avanti completion center discovered this problem and began installing spacers on aircraft with serial number 1063 and onwards. Piaggio (Italy) was also made aware of this defect.

Transport Canada reminds maintainers inspecting or replacing these lamps to ensure adequate clearance with the fuselage.

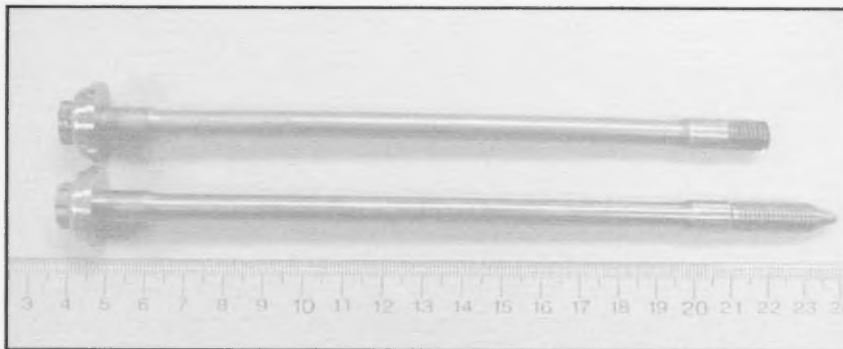
SDR # 20040202015

Tie Bolt Sheared

One of the three bolts, P/N 332A32323300, attaching the engine to the main gearbox was discovered sheared during a turn around check. This bolt was sheared about midway in the threaded portion of the bolt.

The engine was removed and area inspected in accordance with maintenance procedures. The cause of the bolt damage could not be determined.

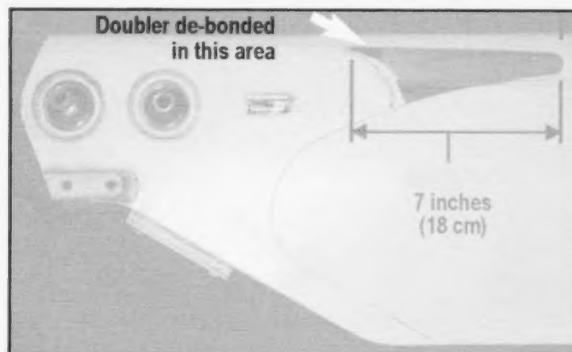
Tail Rotor Blade Doubler Broken Off

Time Since New (TSN): 206 hours

View of the tail rotor blade where the doubler was missing

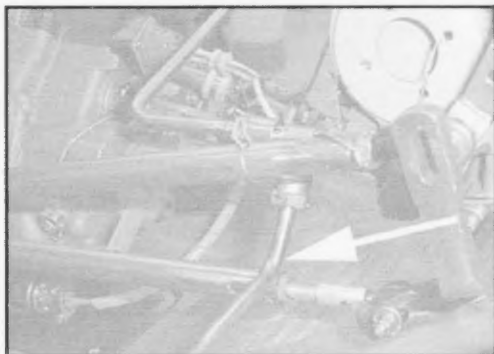
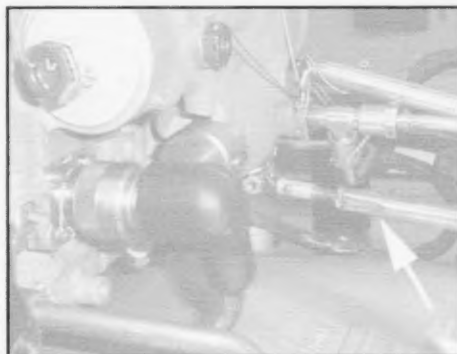
SDR # 20040304008

PCU Rigging

The shop engineer was inspecting the engine when he noticed that the PCU control rod (condition), P/N 87620097-023, was contacting the P3 air pressure sensing line, P/N 3034384, before contacting the HMU stop at max setting.

This occurs when the HMU is replaced and the "T" fitting, P/N MS 9196-04, is not positioned properly and overlooked when rigging is done.

The "T" fitting was repositioned so a gap between the sense line and the control rod was sufficient for full and normal movement of the HMU control rod.

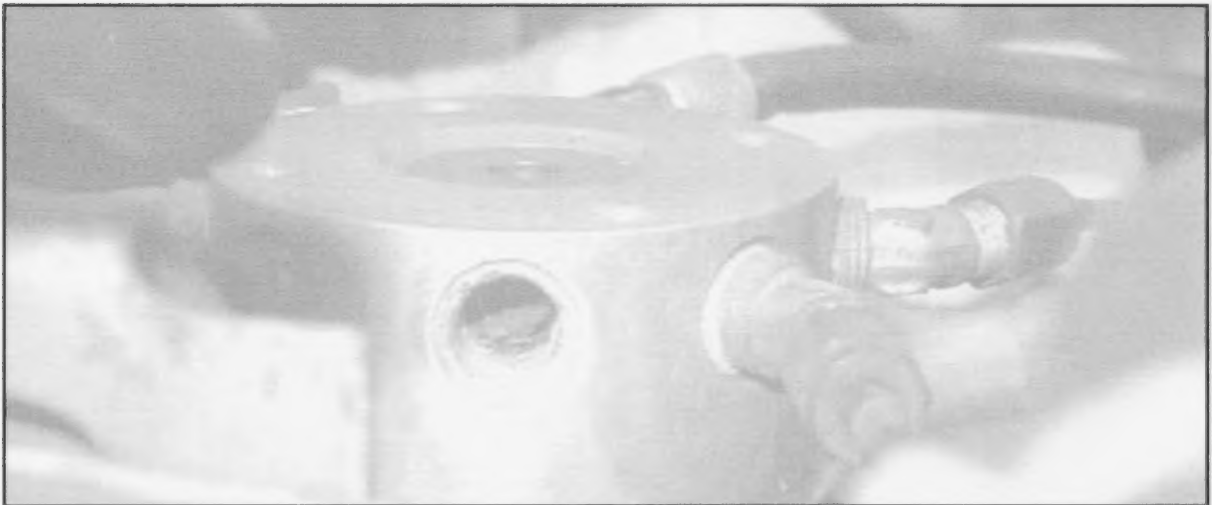
After troubleshooting, maintenance personnel suspected the problem to be either the fuel servo and/or the fuel flow divider, P/N 25242192R. These fuel system components were sent out for repair, bench checked, declared serviceable and returned to the operator. The operator re-installed the flow divider, went flying and experienced another partial power loss.

Once again the operator routed the flow divider to the overhaul facility but when returned had the same unsuccessful results. The above process was repeated over a five (5) month period; successfully passing bench checks; but failing once installed on the aircraft when tested at full power.

The flow divider being used has six (6) ports but only four (4) ports are needed for this particular 4-cylinder engine with the other two ports being capped off. The operator discovered the source of the problem when he uncapped the two unused ports and a large amount of scattered debris fell out. This debris was partially blocking off one or more of the four fuel injector lines causing fuel supply problems to the cylinders.

It appears that the unused caps had deteriorated over several years of inactivity. When aircraft are in storage, rubber and other cork materials will degrade and may result in the contamination of fuel and/or oil systems.
